# memorandum

archifact

**date:** 18 august 2025

**re:** ruakiwi reservoir  
assessment of effects on historic heritage values

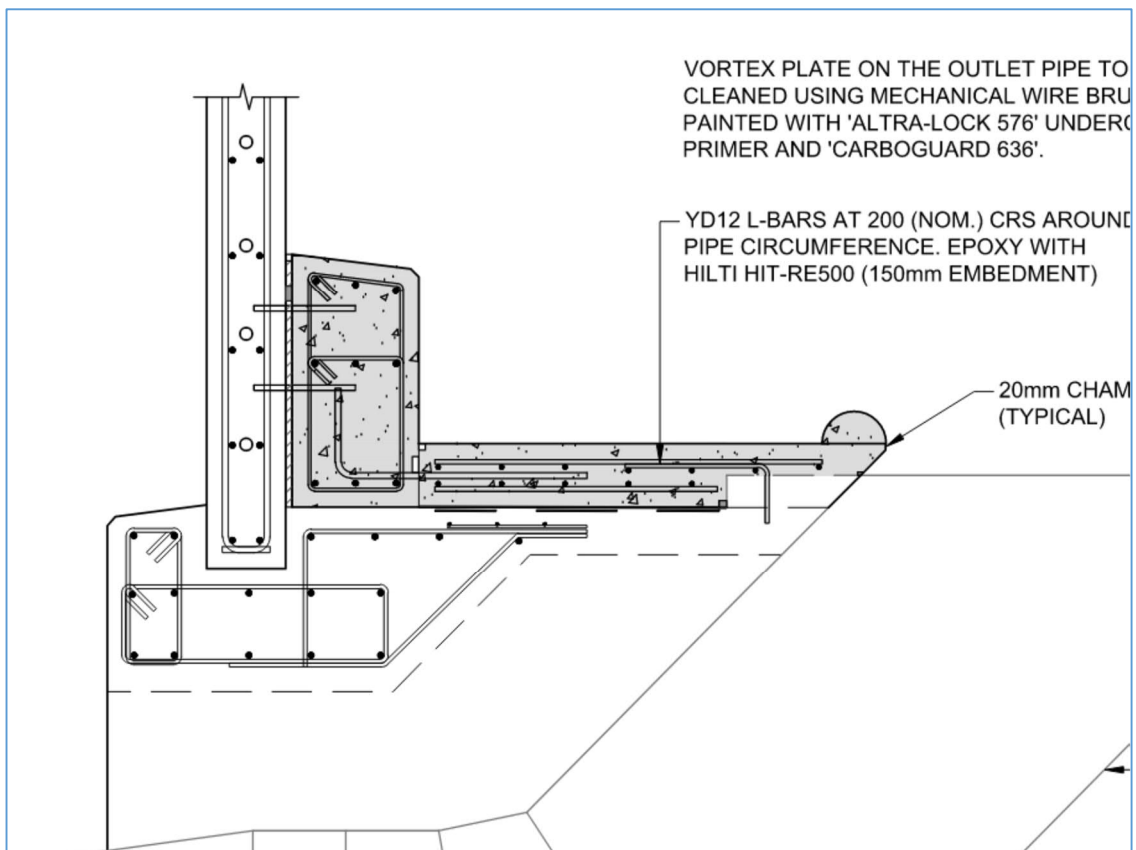
Figure 2: WSP example of typical RC ring beam detail.

The WSP DSA recognised the governing critical structural weakness as being the connection between the reservoir walls and the base slab. This detail consists of the wall sitting on a steel expansion guide with no positive connection between the concrete. Therefore, the only sliding resistance across this plane is friction between the steel plates of the expansion guide. Failure of this connection due to out-of-plane moment exceeding the friction capacity of the steel plates will result in the lateral movement of the walls relative to the base slab and could lead to structural failure.

The lack of any meaningful connection between the reservoir wall and the base slab to resist lateral loading means that the connection between the wall and base slab has been assumed to allow full lateral displacement in both directions. The reservoir wall has no mechanical connection to the base slab. A conservative assumption was made in the DSA that the only resistance for the reservoir structure overturning on the base slab is its own weight and the hollow core columns connected to the base slab. A conservative assumption was also made for the lateral resistance against the reservoir structure sliding off the base slab because of the absence of a mechanical connection between the wall and the base slab, and the lack of quantifiable resistance from the hollow-core columns and the soil profile. The assumption was made that the resistance against sliding would be entirely provided by friction between the wall and base slab, and the nominal resistance provided by the columns and soil would be ignored. The friction between the wall and base slab and the passive soil resistance provide the entirety of the lateral restraint against seismic demand. The capacity provided is not sufficient to overcome the seismic demand, and the reservoir structure above the base slab would be expected to significantly displace relative to the base slab in an IL2 ULS seismic event.

The only element within Ruakiwi Reservoir that requires strengthening is the base to wall connection. The strengthening required would be to implement a reinforced concrete perimeter ring beam that would travel around the inside circumference of the base of the lower reservoir wall. The ring beam would be fixed to both the reservoir wall and base slab through drilled dowels to ensure an adequate structural connection between the two sections.

A typical example of the recommended strengthening is shown in Figure 2 below.

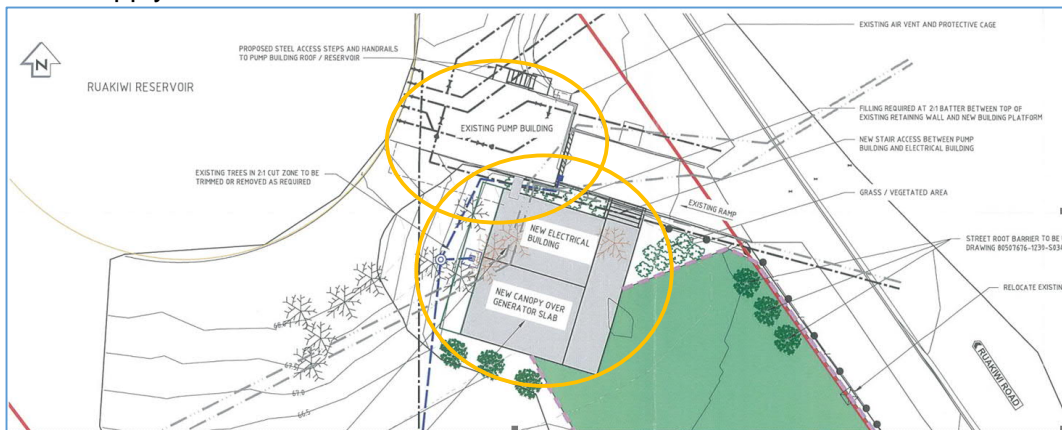
There are a number of non-original (and non-heritage) structures currently associated with the heritage tower that could be removed as part of the proposed works and whose removal would positively add to the mitigation of adverse effects and enhancement of the historic heritage values of the heritage Tower reservoir. Figure 3 (below) provides a plan of existing buildings and elements that would become redundant (circled) in disengaging the heritage tower reservoir from the public potable water supply.

**Figure 3:** Plan view of non-original and non-heritage ancillary elements that could be removed to enhance the heritage reservoir in hand with the proposed landscaping.  
Image: Edwards White Architects

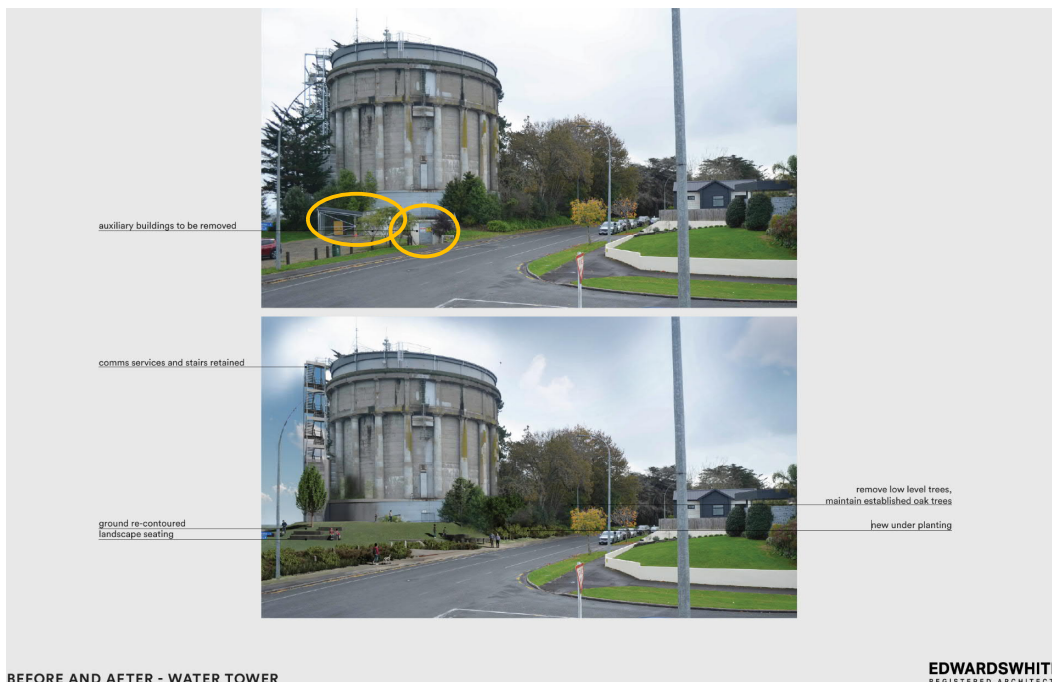
Figure 4 (below) offers a “before” and “after” render of the potential visual enhancement afforded by this action. It is noted that the modern stair access to the roof-mounted communications equipment is required to be maintained at this time.

**Figure 4:** Non-original and non-heritage ancillary elements that could be removed (circled) to enhance the values of the heritage reservoir in hand with the proposed landscaping.  
Image: Edwards White Architects

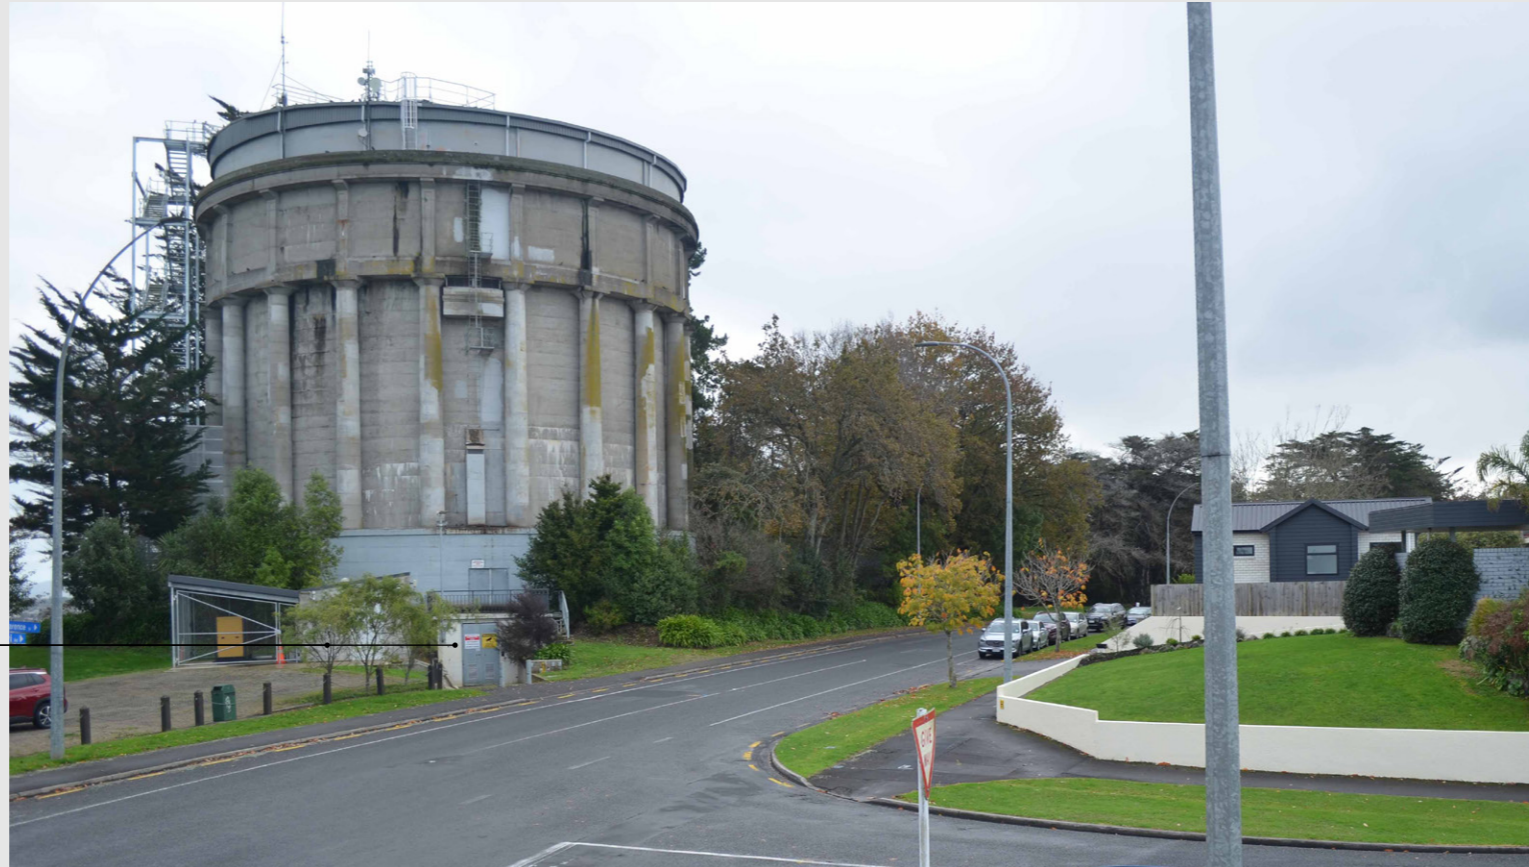
auxiliary buildings to be removed

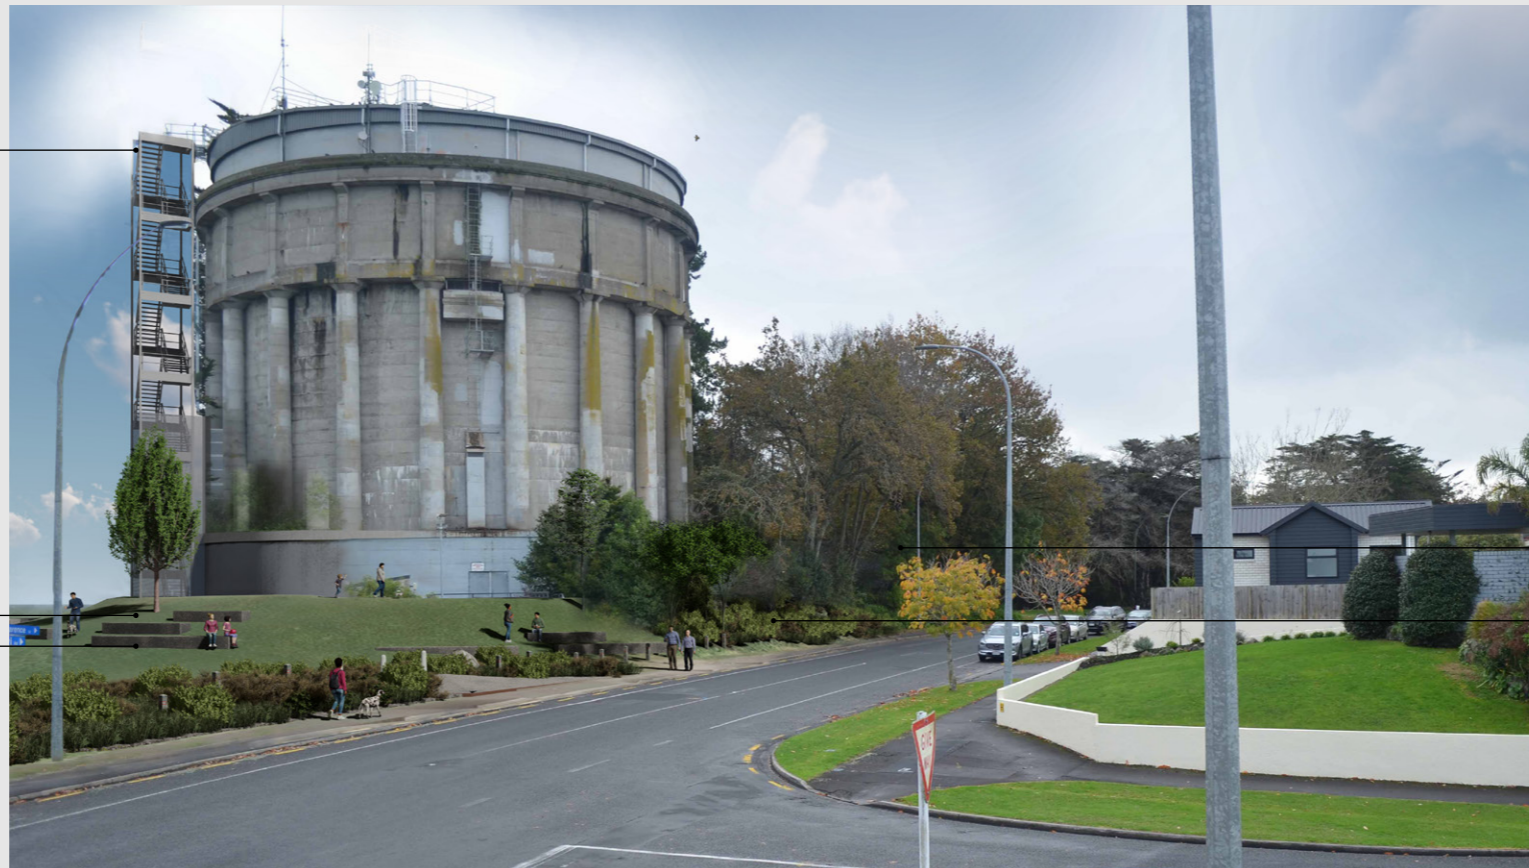
comms services and stairs retained

ground re-contoured  
landscape seating

remove low level trees,  
maintain established oak trees

new under planting
